**Protected Species Monitoring Report: Marine  
Mammals and Marbled Murrelet  
Naval Base Kitsap at Bangor  
EHW1 Pile Replacement Project**

1035 Trident Boulevard  
Silverdale, Washington 98135

May 7, 2024

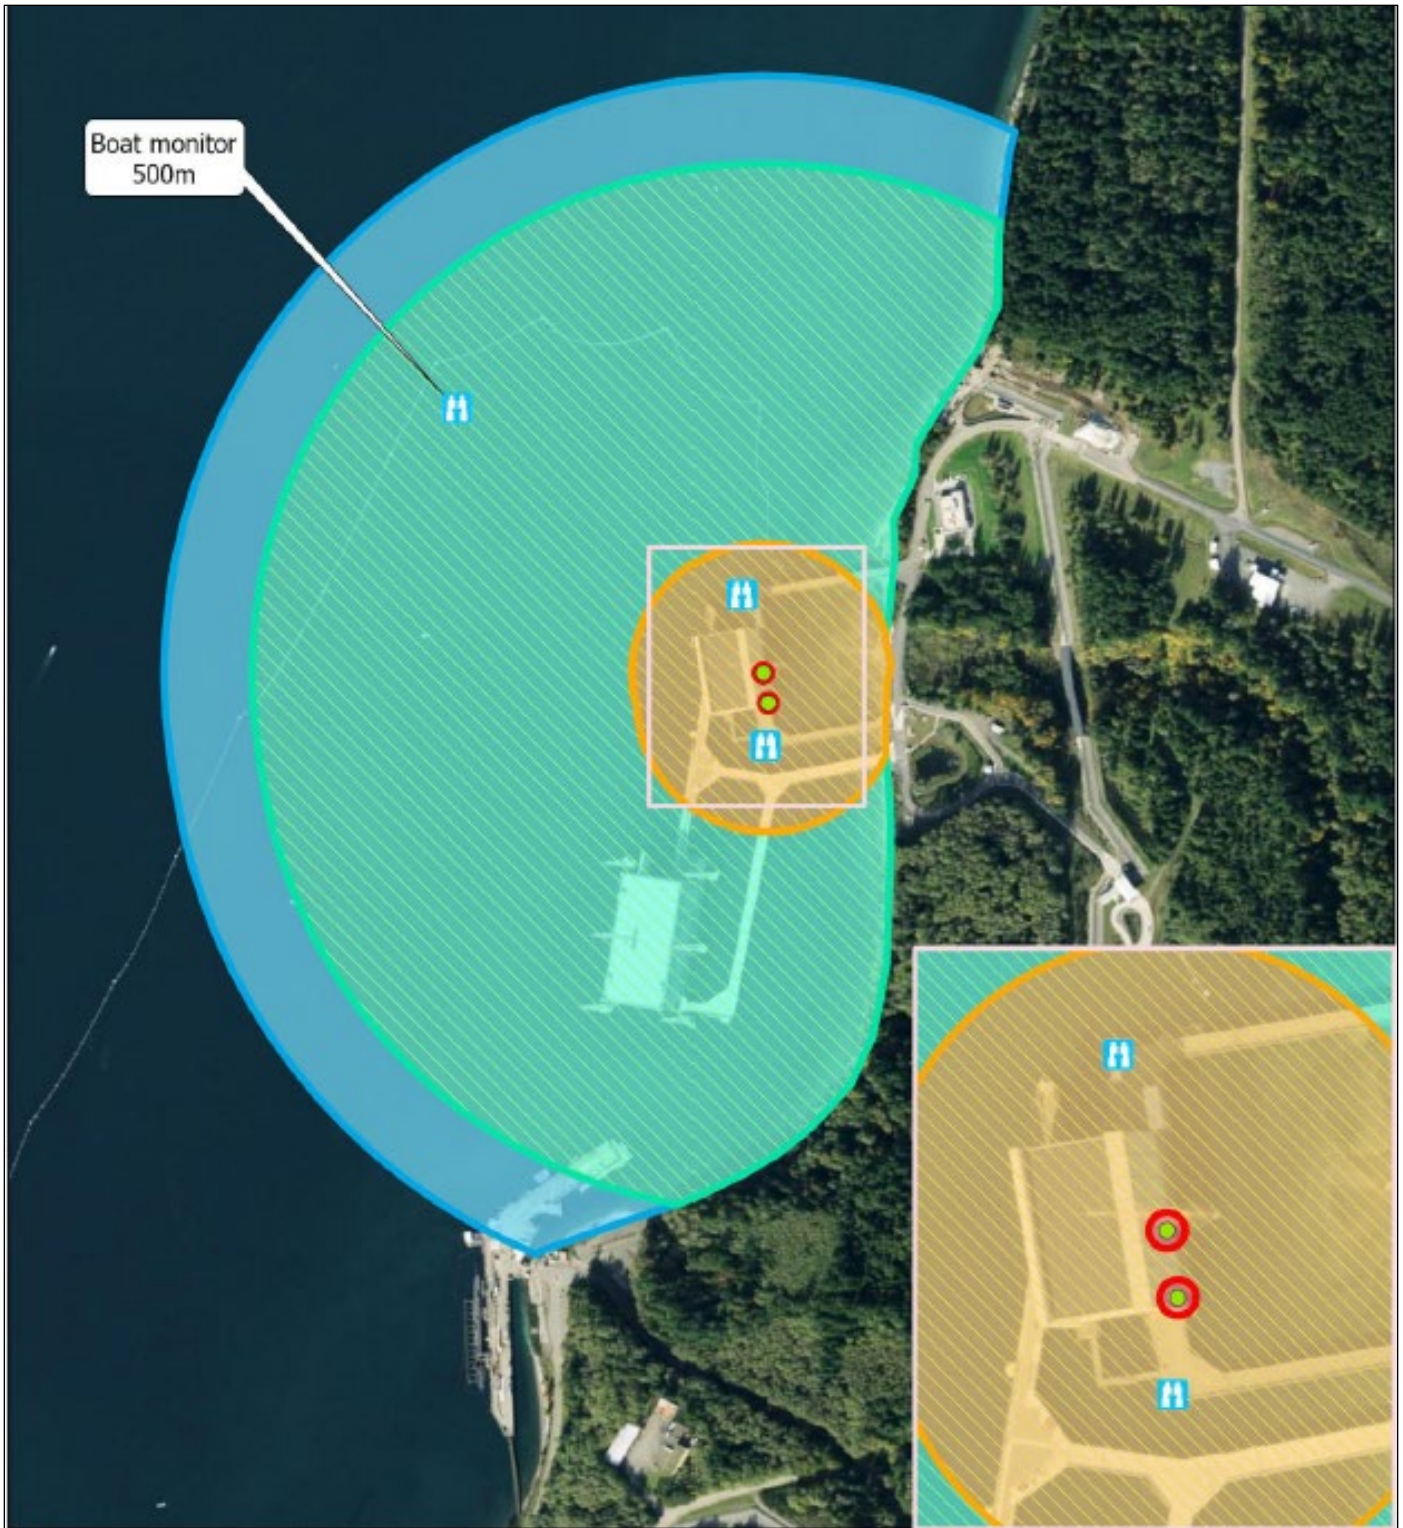
**Figure 2**

Note: Locations and zones dependent on type of equipment used and size of piles. See report for detailed zone descriptions.

**Example Monitoring Zones and Observer Locations**

The monitoring zones were established in the MMMP and included injury and behavioral disturbance monitoring zones (Figure 2, Example Monitoring Zones and Observer Locations).

<sup>2</sup>The estimated Level A harassment zone for low-frequency cetaceans exceeds the estimated Level B harassment zone. Therefore, while the shutdown requirement described applies to the monitoring zone for mid- and high-frequency cetaceans, the de facto minimum monitoring zone is equivalent to the largest shutdown zone (i.e., the 740-meter zone for low-frequency cetaceans, Figure 2).

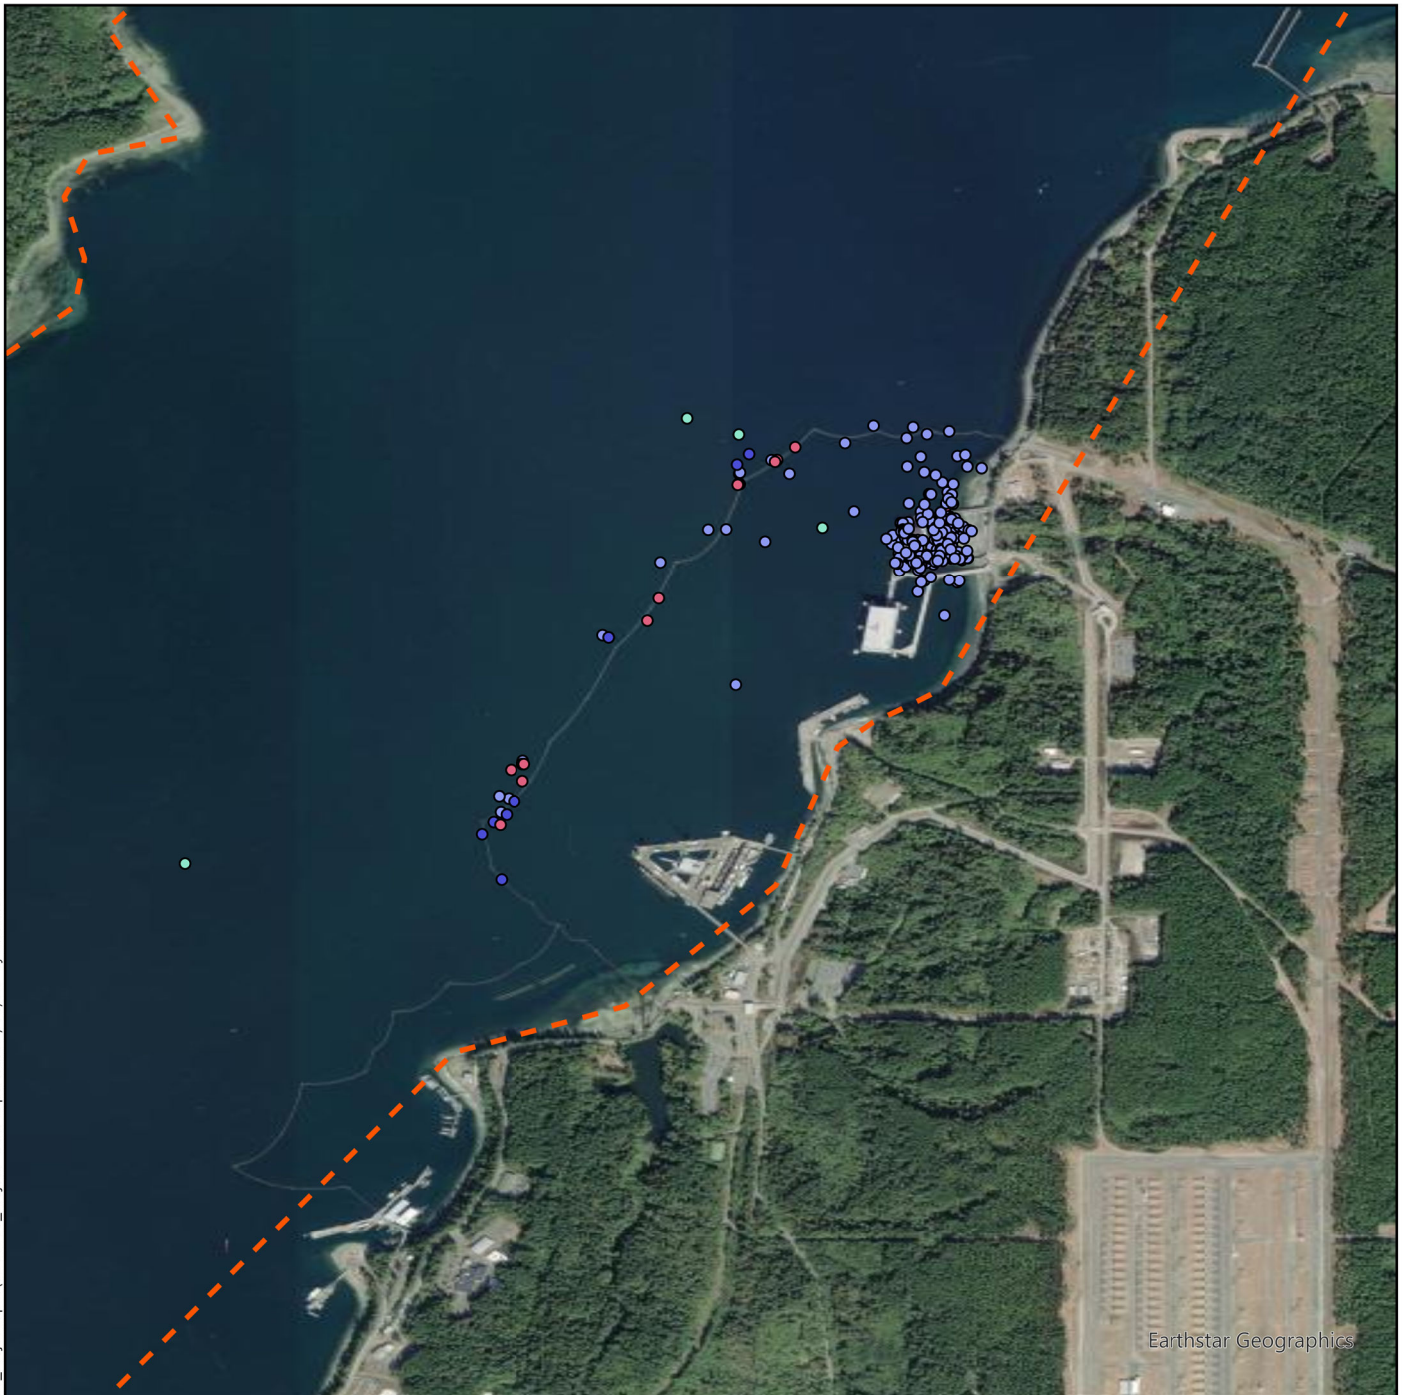
**Figure 3**

**All Observed Marine Mammal Sightings**

A total of 254 marine mammal sightings were observed during the EHW1 Pile Replacement Project timeframe (Figure 3, All Observed Marine Mammal Sightings). Four species were sighted: the California sea lion, stellar sea lion, harbor porpoise, and harbor seal. The harbor seal was the most frequently sighted species by far, followed by California sea lion, stellar sea lion, and harbor porpoise. Potentially resighted individuals were recorded with a probability of re-sightings of 0 to 50, 50 to 70, 70 to 90, and 90 to 100. Sightings included both individuals and groups of individuals.

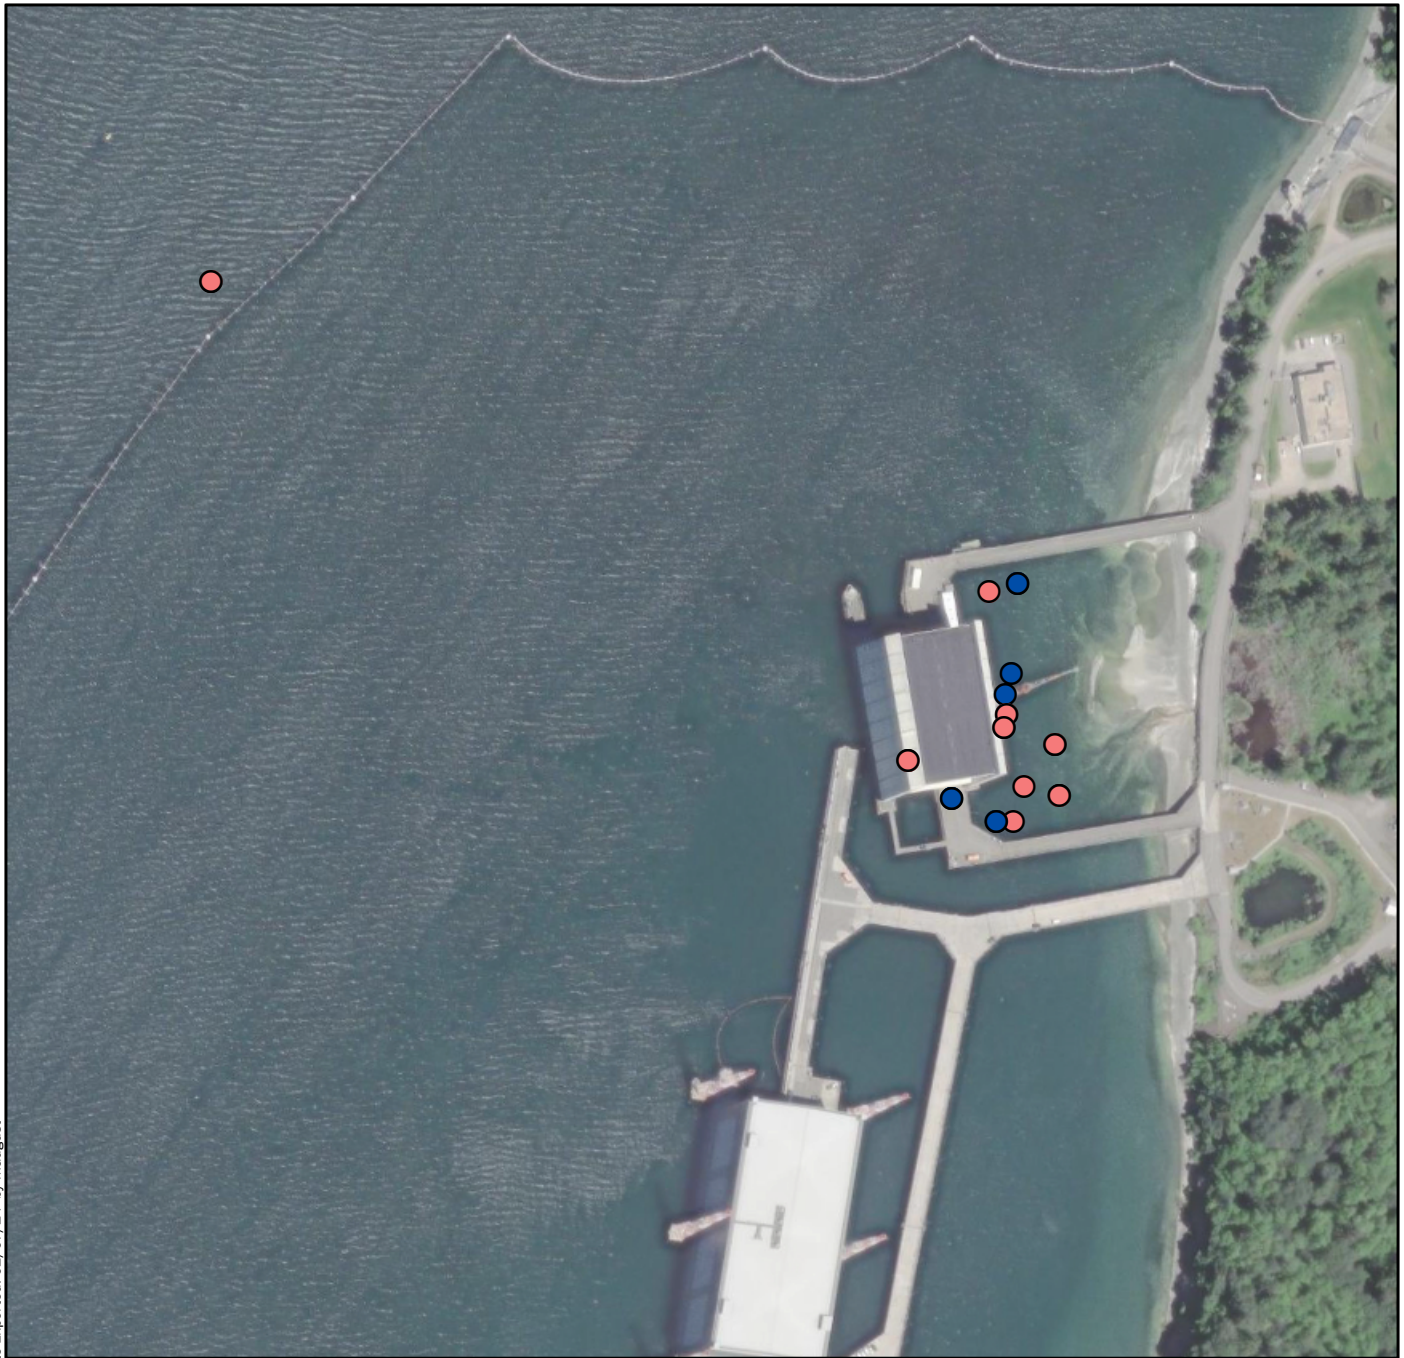
**Figure 4**

**Observed Marine Mammal Takes**

A total of nine (9) Level B and five (5) Level A marine mammal takes were observed over the duration of the project (Figure 4, Observed Marine Mammal Takes). All reported takes were related to harbor seal sightings. The majority of takes were recorded within the EHW1 pier/trestle area, with one instance of Level B take occurring during vibratory pile driving located exterior to the perimeter fence. There were no other takes of other species observed.
