**SR 520 Pontoon Construction Site –
Marine Piling Removal Project
UNDERWATER NOISE MONITORING REPORT**

Prepared by:
Phil Bloch

March 2021

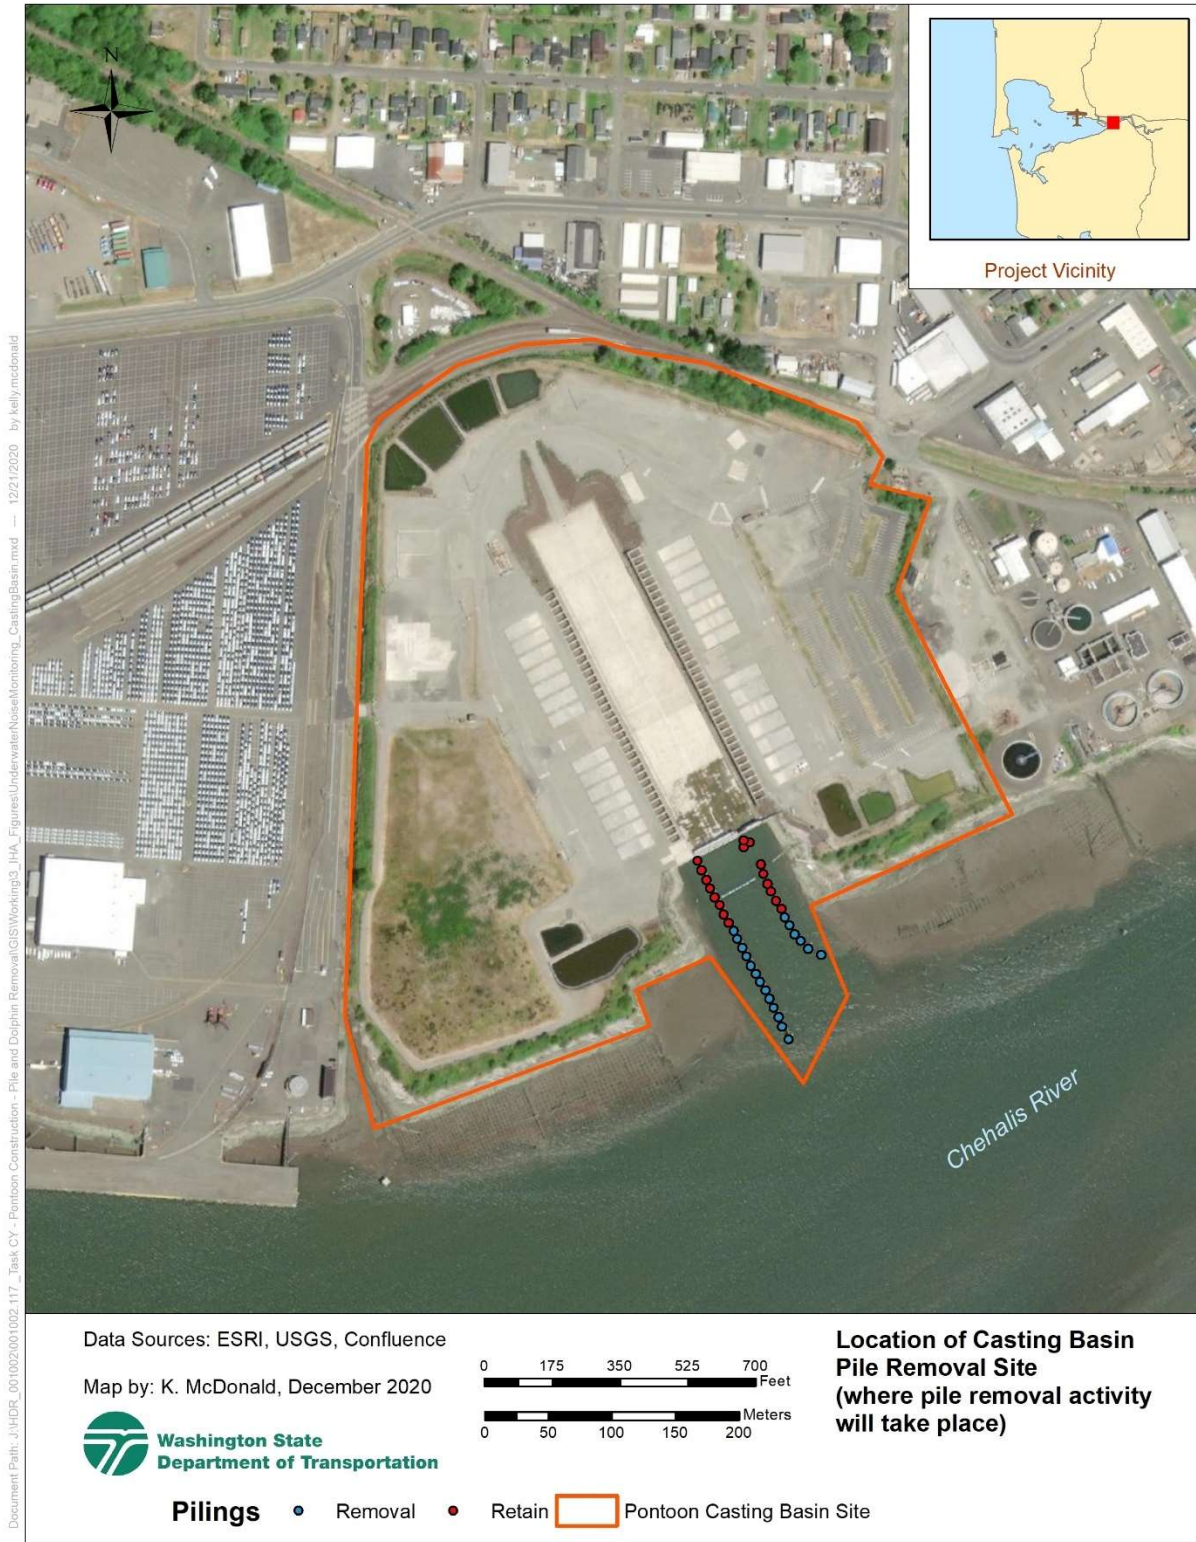
Figure 2. Location of 19 Pilings that were Removed

The 19 pilings were in Grays Harbor at water depths ranging from -3.1 to -9.9 feet mean lower low water (MLLW).

The proposed activities occurred waterward of the Pontoon Casting Basin located in Grays Harbor in the City of Aberdeen, Washington (see Figures 1 and 2). Figure 2 indicates the location of the pile removal.

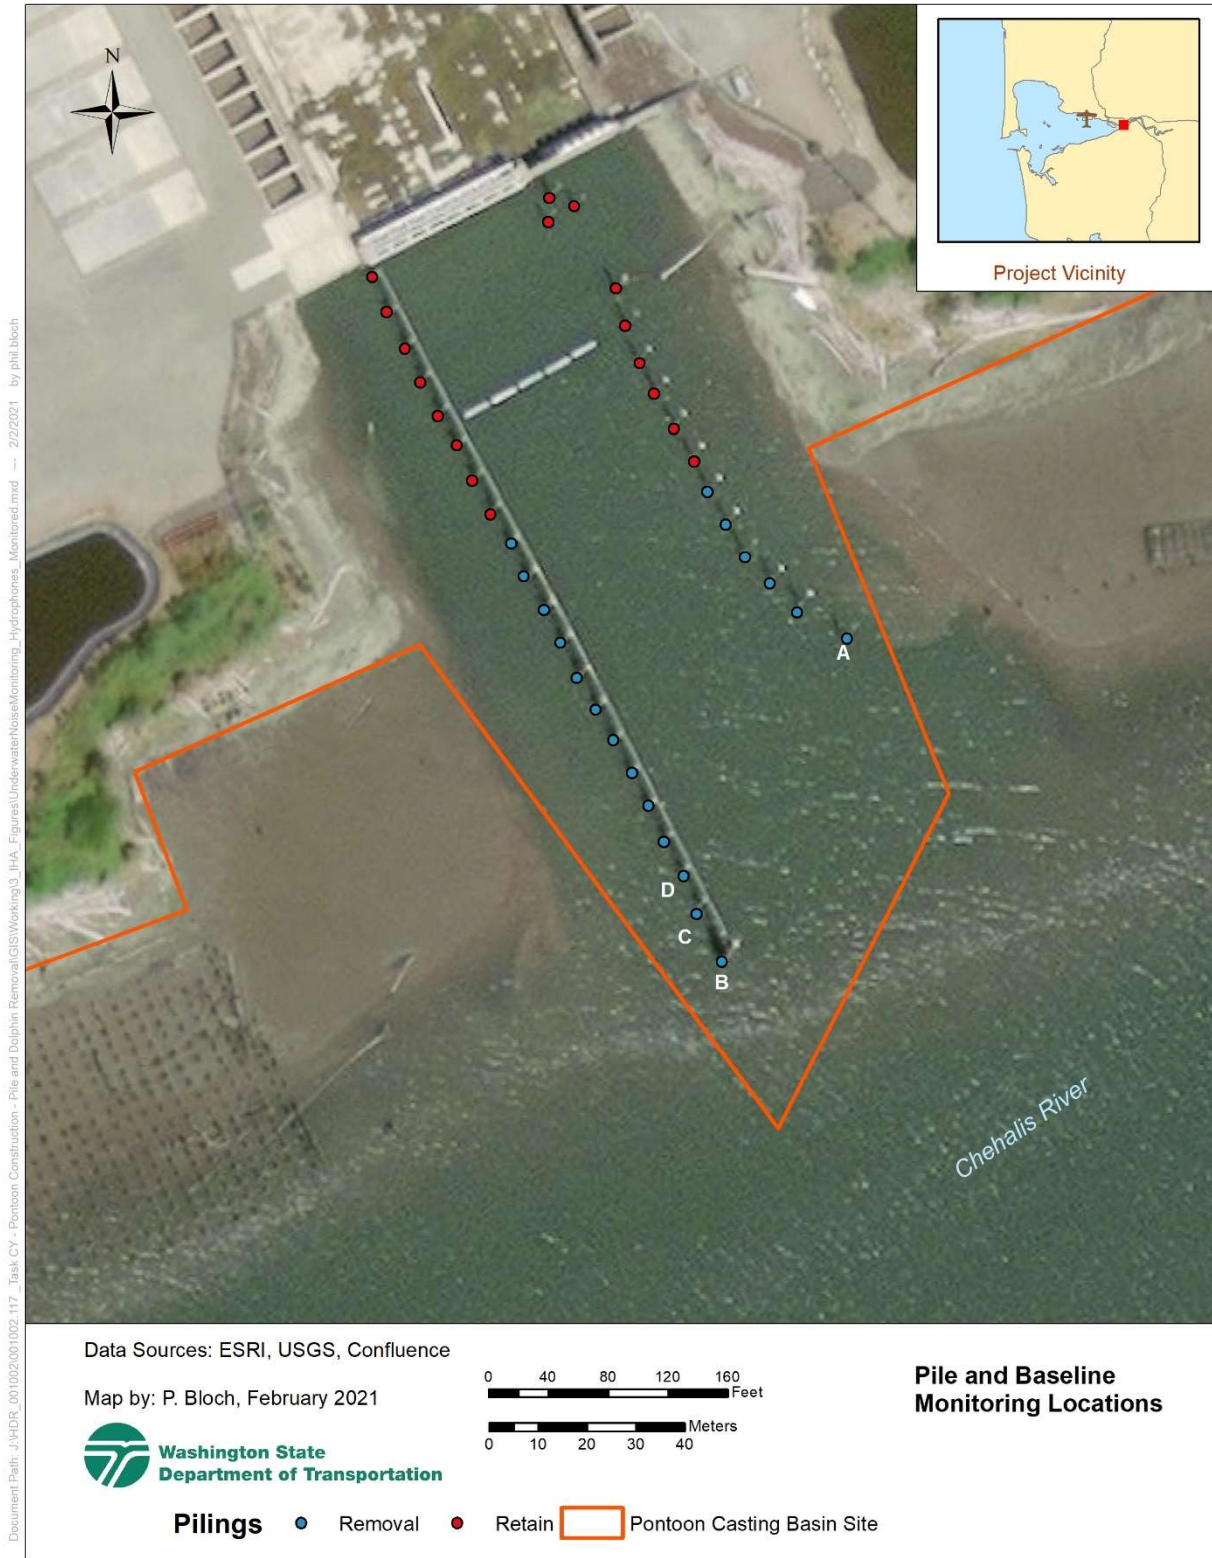
Figure 3. Location of the Monitoring at the Casting Basin Pile Removal Site

Monitoring and removal operations occurred on January 26, 2021, from a monitoring vessel, with baseline monitoring occurring at location A, and removal operations monitoring occurring at locations B-D (Figure 3). During monitoring, the monitoring vessel was either tied to a piling

for baseline monitoring (location A) or anchored for removal operations (locations B-D). The hydrophone was at a depth of approximately 2 meters for all monitoring efforts. On January 26, low tide was at 3:00 AM with a predicted height of 4.49 feet MLLW, and high tide was at 11:03 AM with a predicted height of 10.64 feet MLLW (NOAA Station 9441187, Aberdeen, WA). Weather was overcast, with light to moderate wind during the noise monitoring period and light, intermittent rain occurring at the end of the monitoring period. The configuration of the barge, crane, and vibratory hammer during typical operations is shown in Figure 4. Underwater noise levels observed are reported in Table 2.

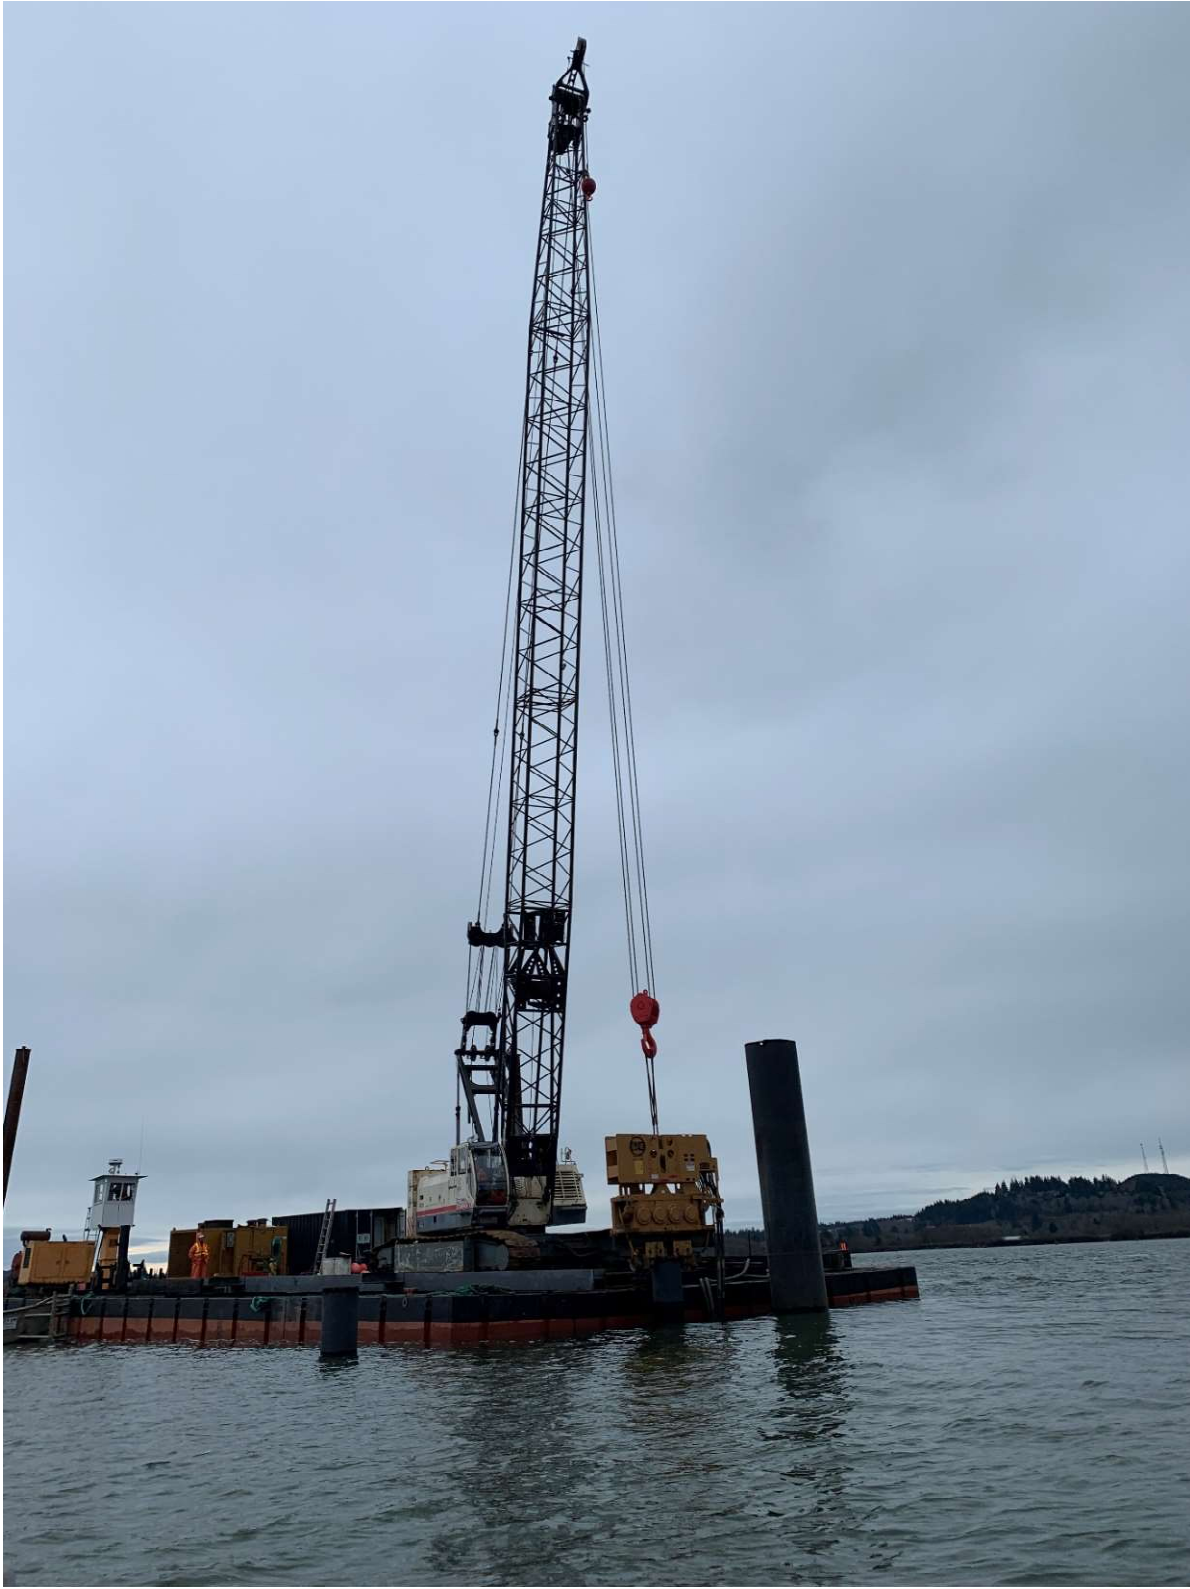
Figure 4. Vibratory Hammer Removal Operation on 24-Inch Piling

The monitoring vessel was at anchor on the west side of the 24-inch pile, approximately 25 meters from the pile. During pile removal, the crew lifted the pile released after approximately 30 seconds of vibration and was raised to a height of approximately 40 feet above initial location, with the vibratory pile driver still operating. In total, the vibratory hammer was active for approximately 7 minutes 40 seconds. At this point the removal operation paused as lifting points were cut in the upper segment of the pile. The pile was cut approximately 10 feet above the waterline. The upper pile segment was then lifted onto the barge, and the lower pile

segment was refitted with a loop and the crane was used to simply pull the remaining pile segment from the substrate. The removal of the remaining pile segment was rapid.

Prior to removal, lifting points were added to the top of the pile. During pile removal, the crew lifted the pile after approximately 30 seconds of vibration and the pile was raised to a height of approximately 40 feet above initial height while the pile driver continued to operate. In total, the vibratory hammer was active for approximately 6 minutes 40 seconds. At this point the removal operation paused as the pile was cut approximately 10 feet above the waterline. The remaining segment of the pile was removed by the crane, as described in the section above.
