Elkhorn Slough Tidal Marsh Restoration Project
Phase III
Post Construction Marine Mammal Monitoring Report
10/2024

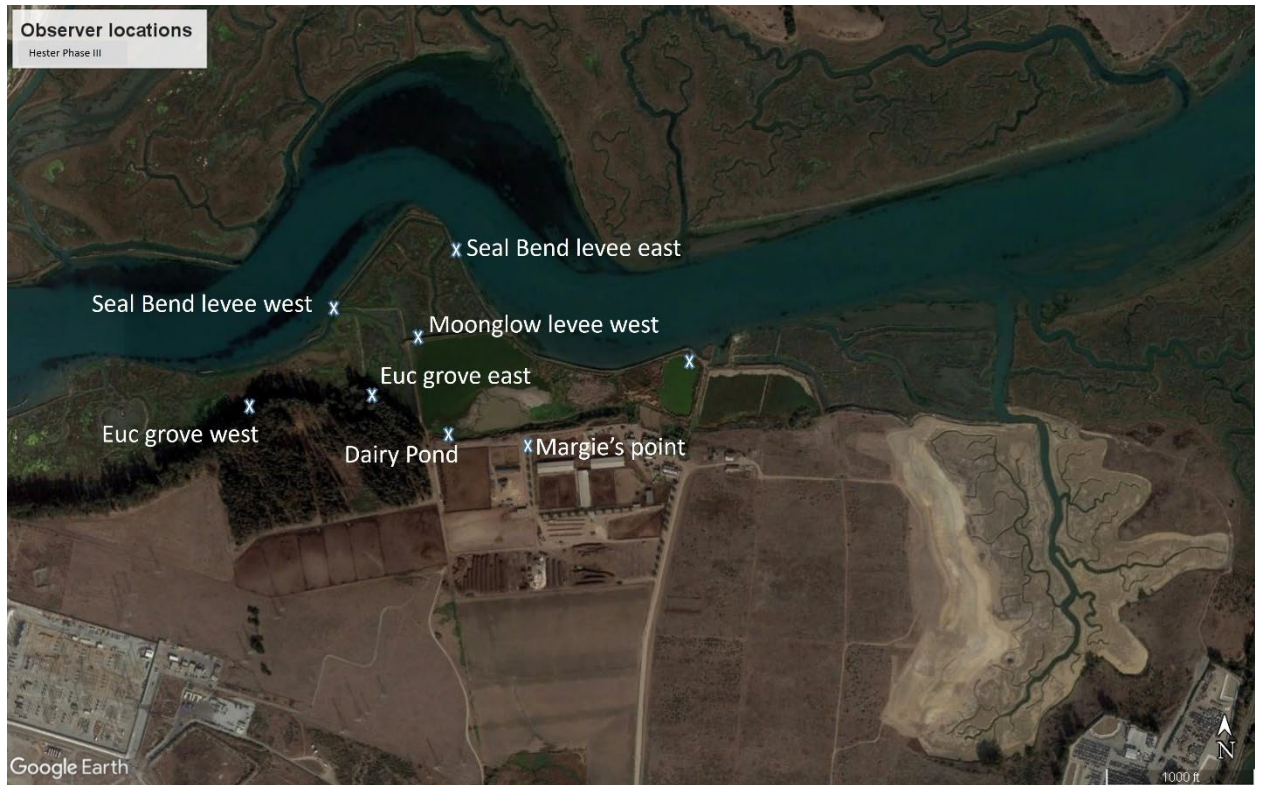
Figure 2. Observation posts

Note: Some areas within the marshes cannot be seen at low tides which necessitated observers moving throughout the project area.

Observation locations (Figure 2)

Monitoring during construction occurred from the best vantage point, at a safe distance from moving equipment. It was accessed by foot and provided a vantage

point of the entire construction area and main channel of Elkhorn slough. This includes the entire area within which harbor seals might be expected to experience disturbance due to construction activities.
