Salmonid Habitat Restoration Priorities (SHaRP) Action Plan for Four Lower Russian River Tributaries

Russian River SHaRP. 2024. Salmonid Habitat Restoration Priorities (SHaRP) Action Plan for Four Lower Russian River Tributaries. California Department of Fish and Wildlife and National Oceanic and Atmospheric Administration Fisheries, Santa Rosa, CA. 118 pages.

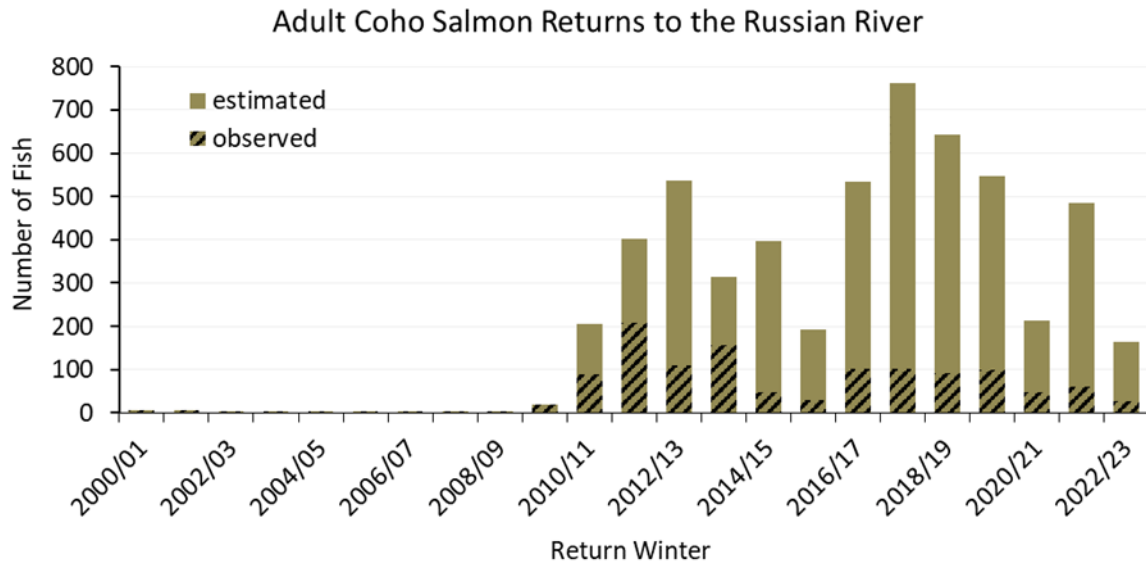
Figure 3. Estimated annual adult hatchery Coho Salmon returns to the Russian River, winter seasons 2000/01-2022/23. Methods for estimating the total number varied between years (CSG 2023).

The Russian River basin was included in the NCSP because it plays a central role in any CCC Coho Salmon recovery scenario, with 457.5 miles of potential habitat and a down-listing goal of 5,050 (delisting goal of 10,100) returning adults (NMFS 2012). The federal Coho Salmon Recovery Plan (NMFS 2012) divides the CCC ESU into five diversity stratum. Of these, the coastal diversity strata include the Russian River and Lagunitas Creek (both designated as historically Functionally Independent Populations (FIPs)) and Walker Creek (designated as a Potentially Independent Population (PIP)). The viability criteria outlined in the Recovery Plan requires that at least 50%, or a minimum of two, of all FIPs and PIPs in each diversity strata must be at low risk of extinction for the ESU to be viable (i.e., delisted). Consequently, for the coastal diversity strata to become viable, Lagunitas Creek, the only extant Coho Salmon population with persistent natural production, must be joined by sustainable natural production in either the Russian River or Walker Creek. Between these latter two, the Russian River was chosen for inclusion in the NCSP because of its annual adult Coho abundance (Figure

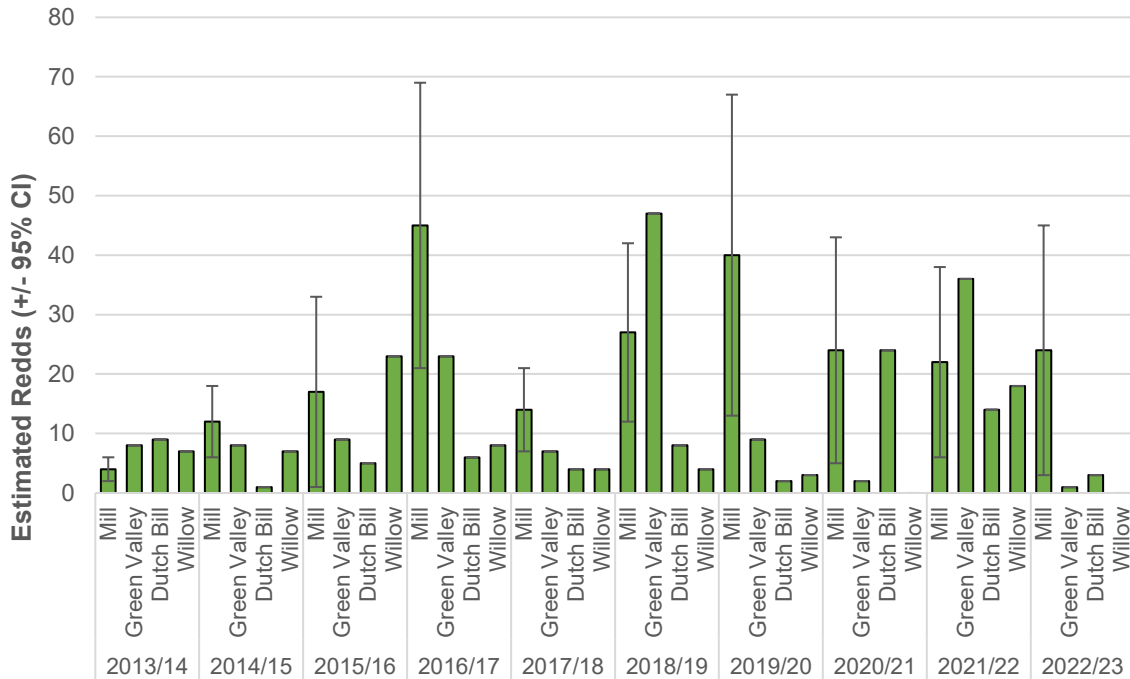
Figure 4. Estimated Coho Salmon redd abundance in LCM tributaries by spawner season, 2013/14-2022/23). Restricted access in Mill Creek caused gaps in the data, thus values were estimated using sampling expansions and confidence intervals are provided (SW and CSG 2023).

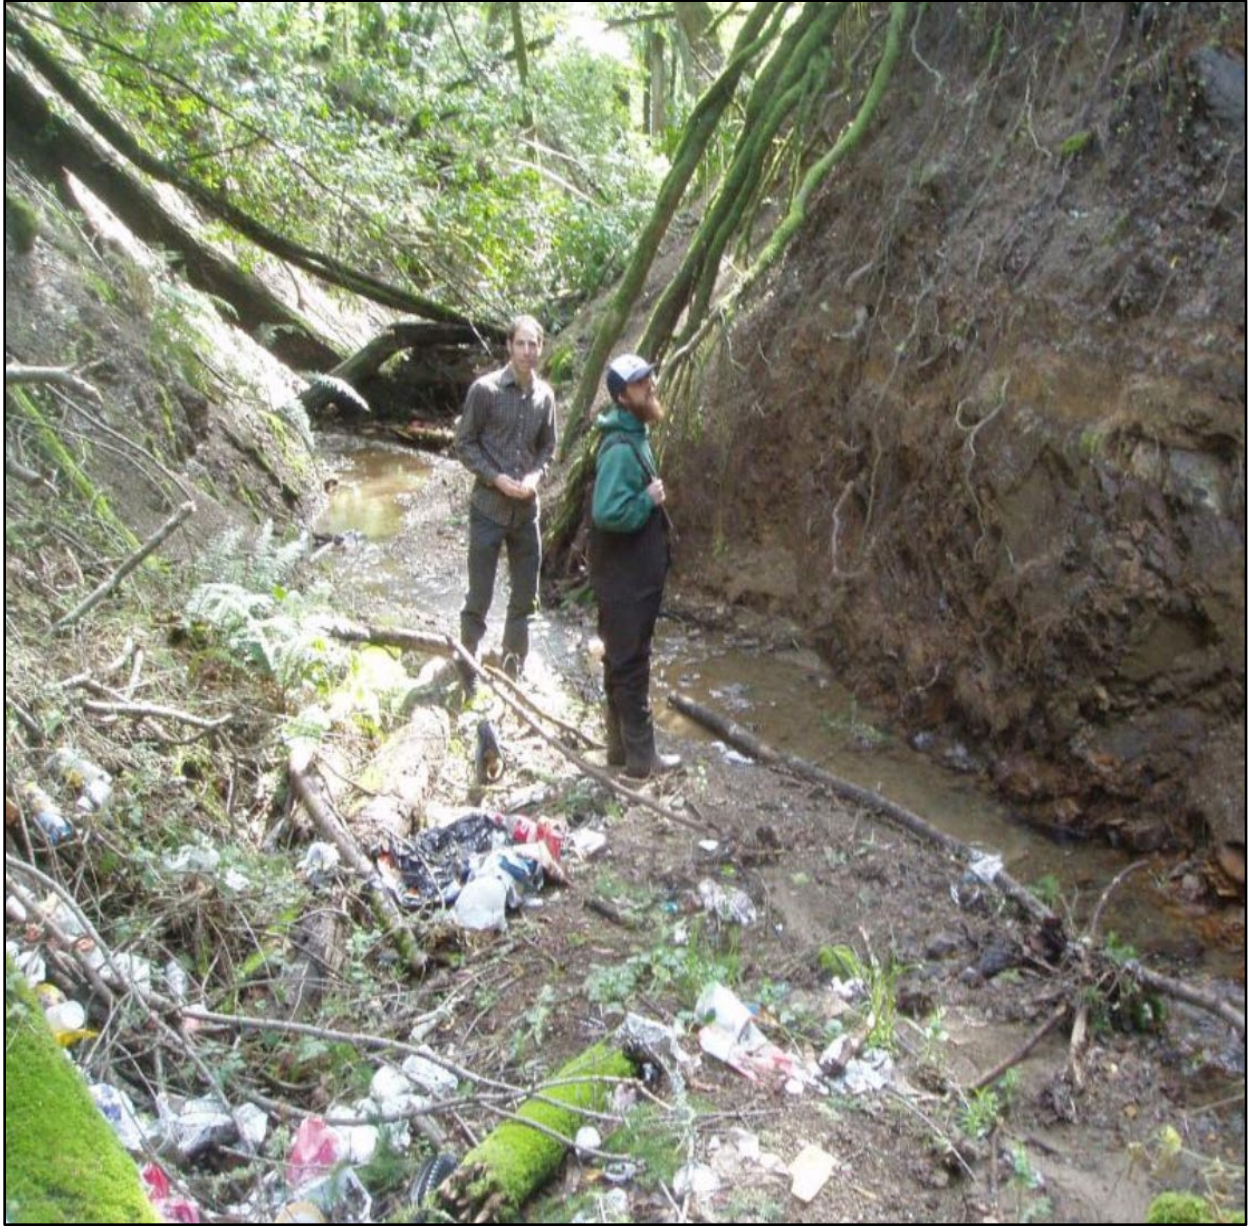
Figure 11. Deep incision and trash dump, Purrington Creek at Graton Road pullout (OEI SHaRP presentation 2022).

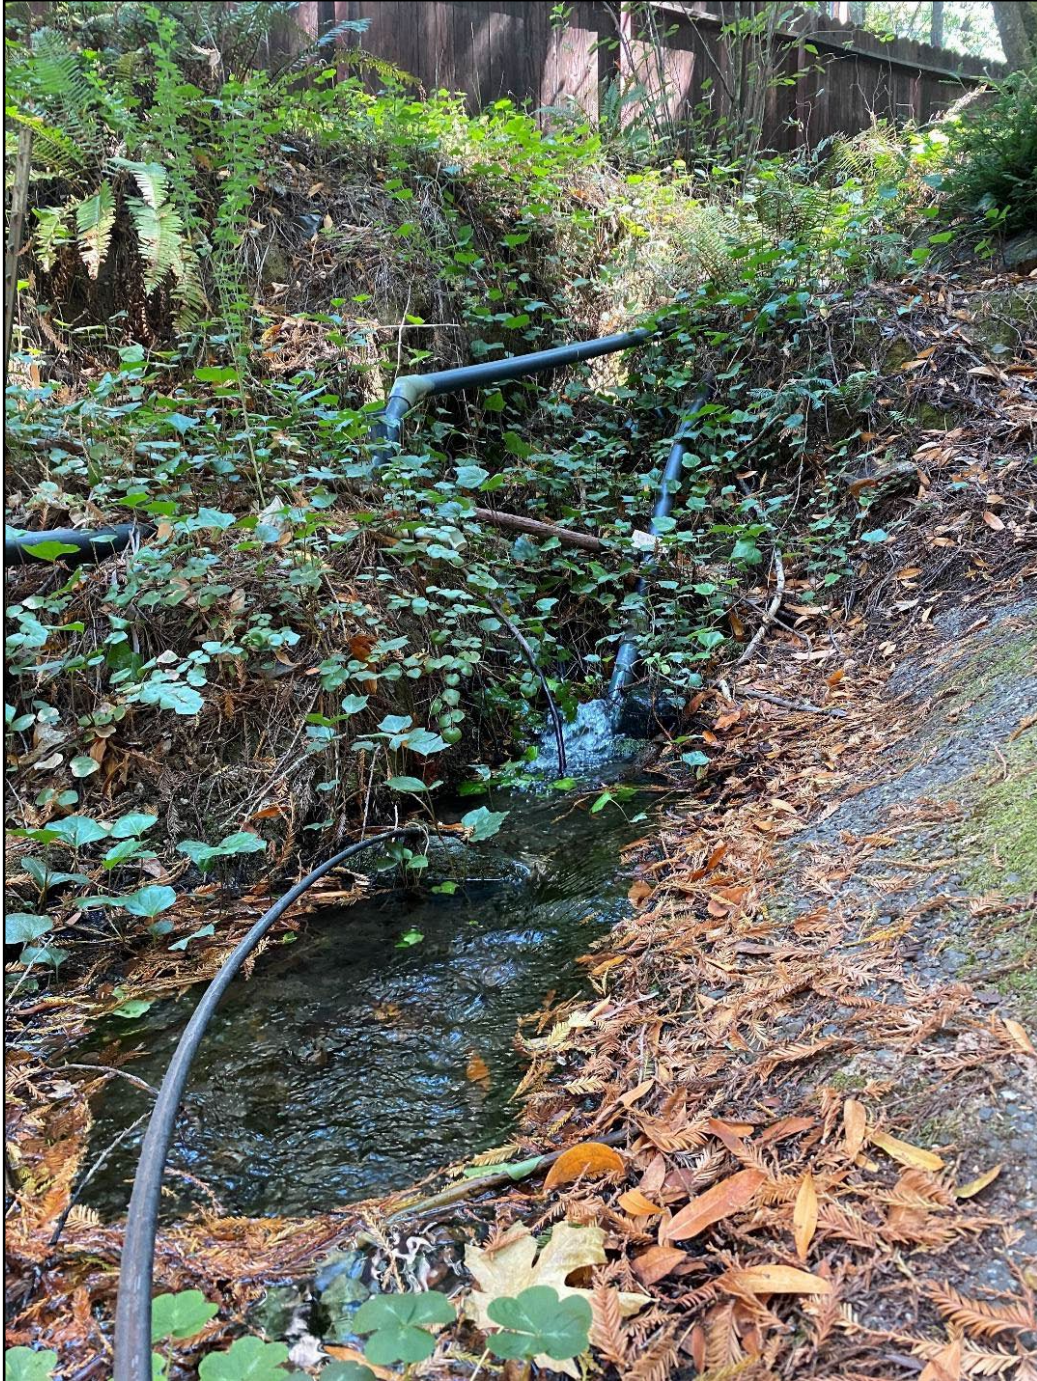
Figure 18. Camp Meeker flow release site.

Water releases are not considered long-term fixes to impaired watershed processes, but temporary solutions designed to sustain connectivity between pools through the dry summer and fall seasons.
